LOWER TWIN LAKE DAM

NDI ID NO. PA-00132

**PHASE I INSPECTION REPORT
NATIONAL DAM INSPECTION PROGRAM**

MAY 1981

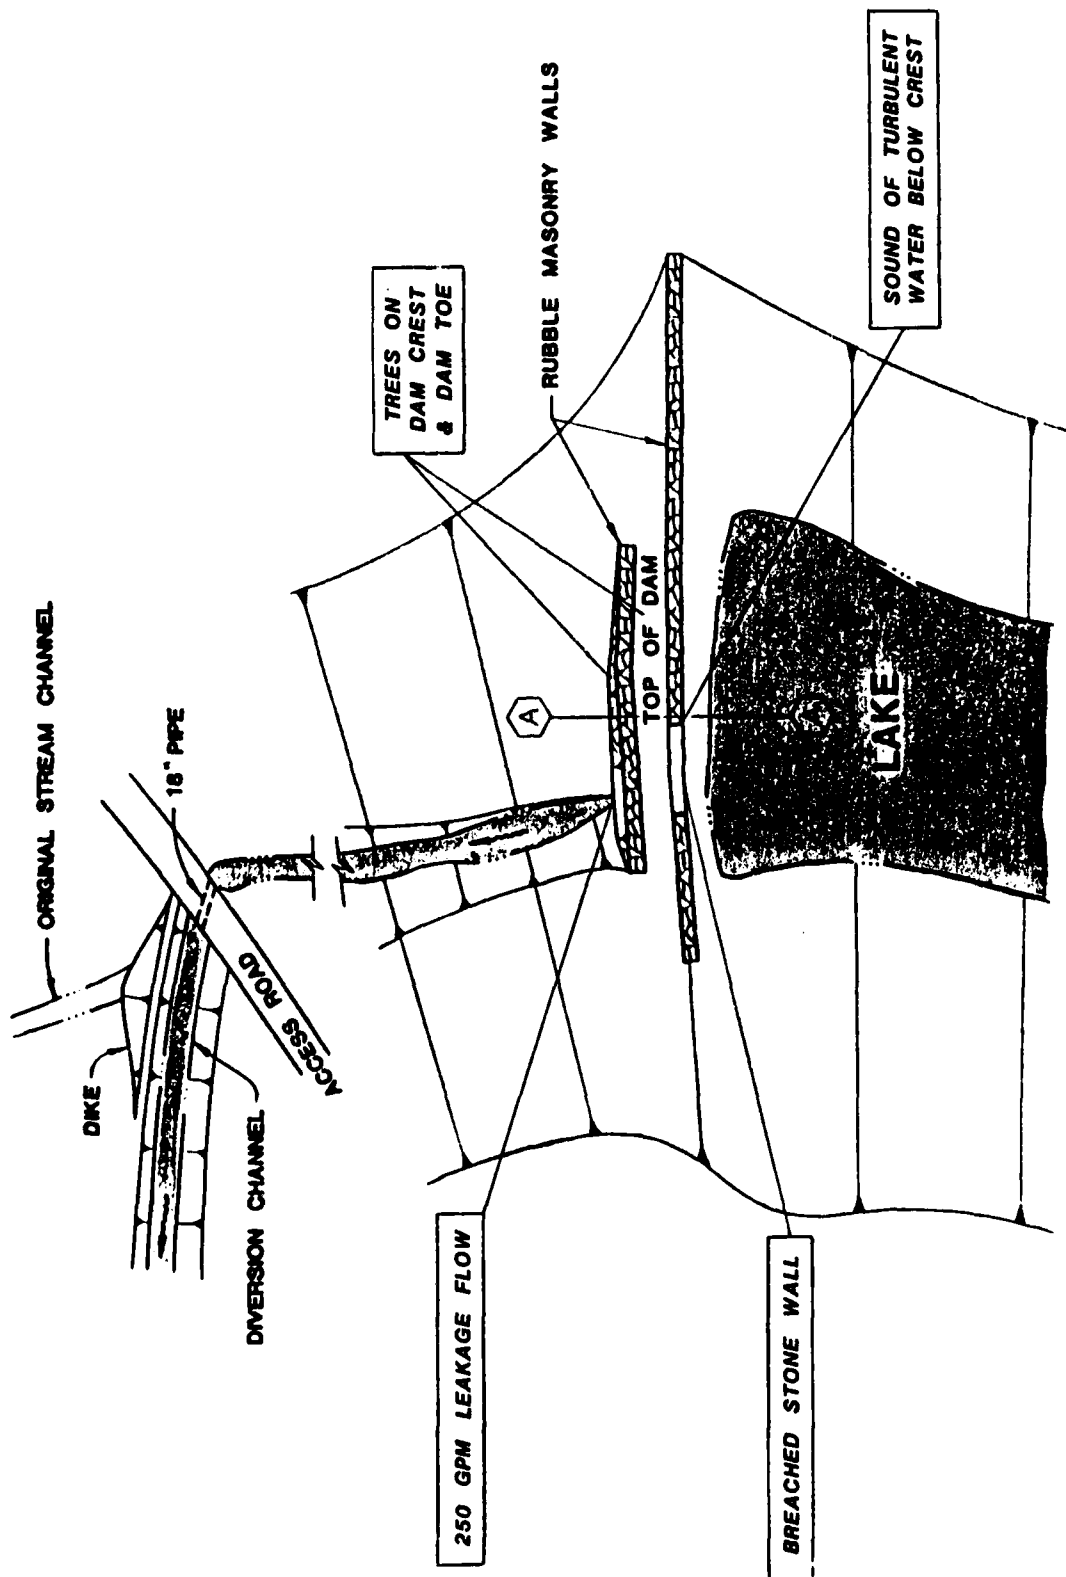
LOWER TWIN LAKE DAM GENERAL PLAN - FIELD INSPECTION NOTES

a. General. The overall appearance of the dam is poor. Location of observed deficiencies are shown on the General Plan presented in Exhibit A-1, Appendix A. The profile and typical sections of the dam are presented in Exhibits A-2 and A-3 and are based on field survey made on the day of inspection. The survey datum for this inspection is elevation 1495 feet above mean sea level for the normal water surface of the lake (see Exhibit E-1). On the inspection date (12/02/80), the lake level was approximately at elevation 1495, which is 1.5 feet below the low point on the dam crest (see Exhibit A-3). Deficiencies observed during the field inspection are described below, and are further illustrated in Exhibit A-1, Appendix A. Visible features are depicted in photographs presented in Appendix C.
